Hollow Cathode Life Test for the Next-Generation Ion Engine in JAXA

IEPC-2007-89

*Presented at the 30th International Electric Propulsion Conference, Florence, Italy
September 17-20, 2007*

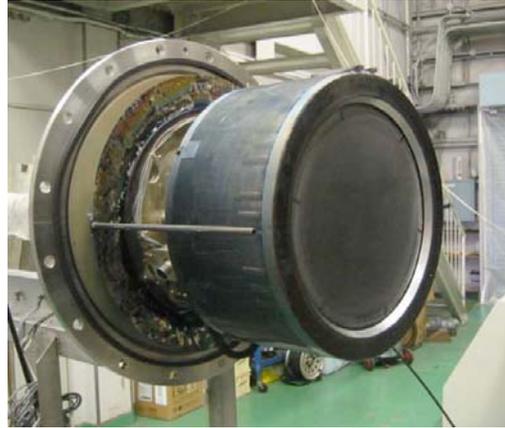
Figure 1. Breadboard model of JAXA next-generation ion engine.

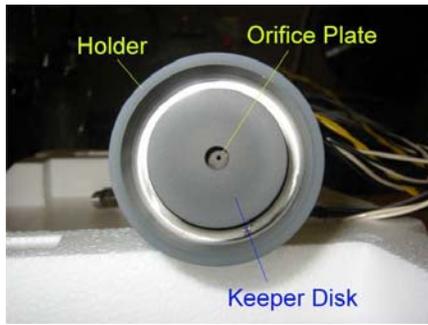
(a) Front view

Figure 2. Graphite hollow cathode.

A graphite discharge cathode⁹ shown in Fig. 2 was finally developed after try and error efforts. In this cathode, the keeper disk, orifice plate, and cathode tube are made of graphite called "high density graphite." In building hollow cathodes, the machinability of material constrains the dimensions and shapes. Certain configurations cannot be formed with graphite even though it could be formed with metals because, e.g., forming a thin tube with graphite is very difficult. The graphite hollow cathodes used in this research were not the same in shapes as the metal hollow cathodes ever used on this account. In addition, connecting graphite parts with other metal parts needed some sophisticated techniques. The cathode insert is composed of a porous tungsten body impregnated with barium oxide. The cathode can emit a current up to 21 A, which corresponds to 200-mN thrust operation of the next-generation ion engines.
